IN THE UNITED STATES DISTRICT COURT
FOR THE SOUTHERN DISTRICT OF TEXAS
MCALLEN DIVISION

Re: Our Client: Erica Chavez
Claim No.: 53-587P-759
Date of Loss: May 28, 2014

R J Molina Estimating

Insured: Erica Chavez
Property: 6597 FM 1430
Rio Grande City, TX 78582

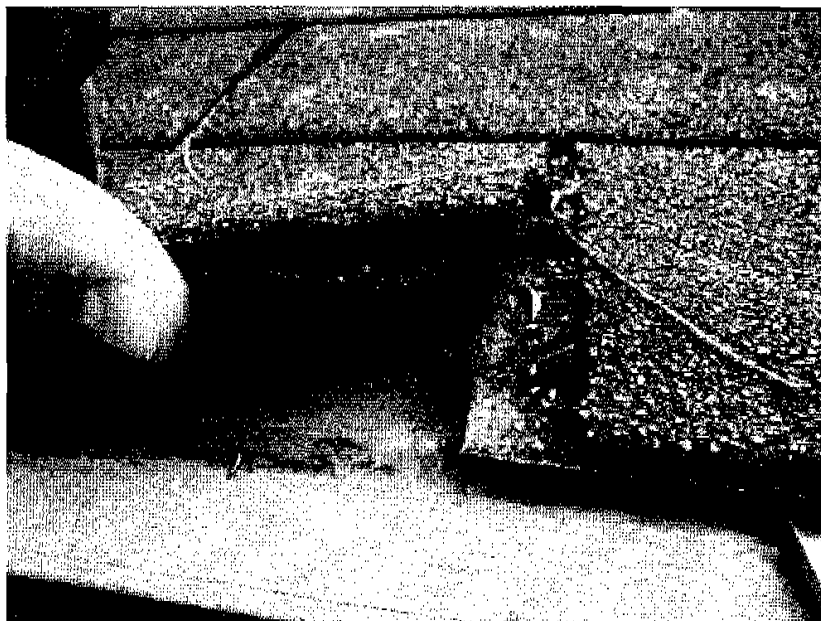
- 5 DSC00747
Date Taken: 1/29/2014
Taken By: Robert Molina
Single layer with starter.

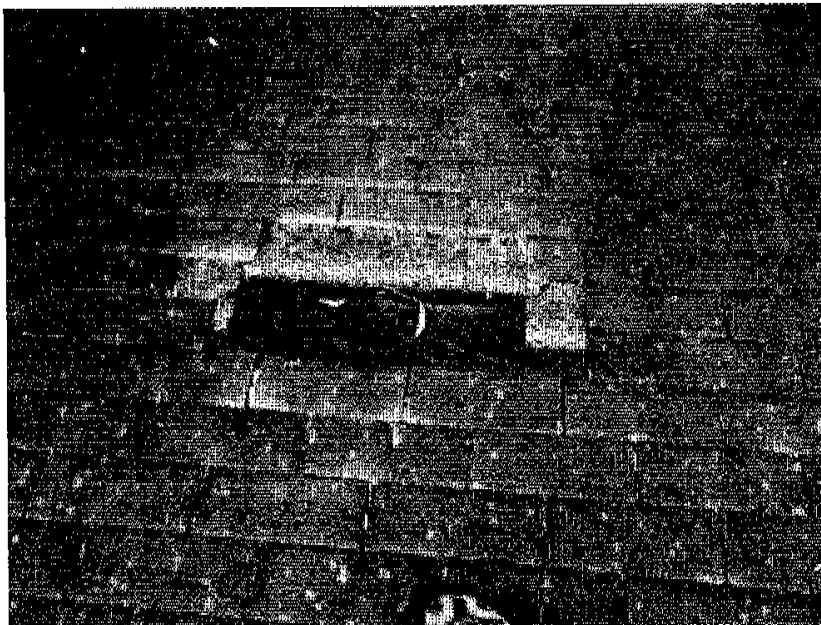
11 DSC00754

Wind damaged shingles.

Roof						
DESCRIPTION	QTY	REMOVE	REPLACE	TAX	O&P	TOTAL
1. Remove 3 tab - 25 yr. - composition shingle roofing - incl. felt	23.33 SQ	56.98	0.00	0.00	265.86	1,595.20

2. 3 tab - 25 yr. - composition shingle roofing - incl. felt	26.00 SQ	0.00	187.76	177.01	1,011.76	6,070.53
3. R&R Sheathing - plywood - 1/2" CDX	200.00 SF	0.40	1.85	13.20	92.64	555.84
For soft areas on roof.

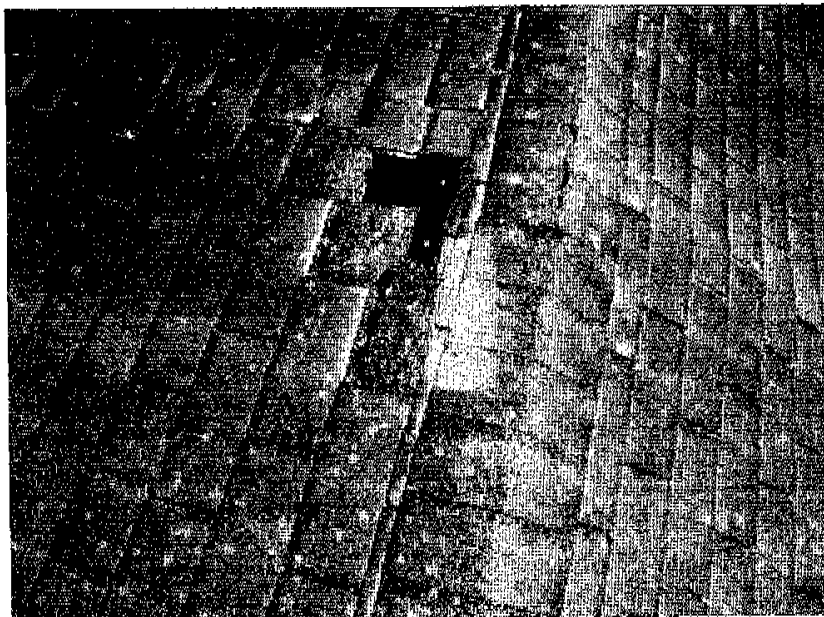
12 DSC00755

Wind damaged shingles.

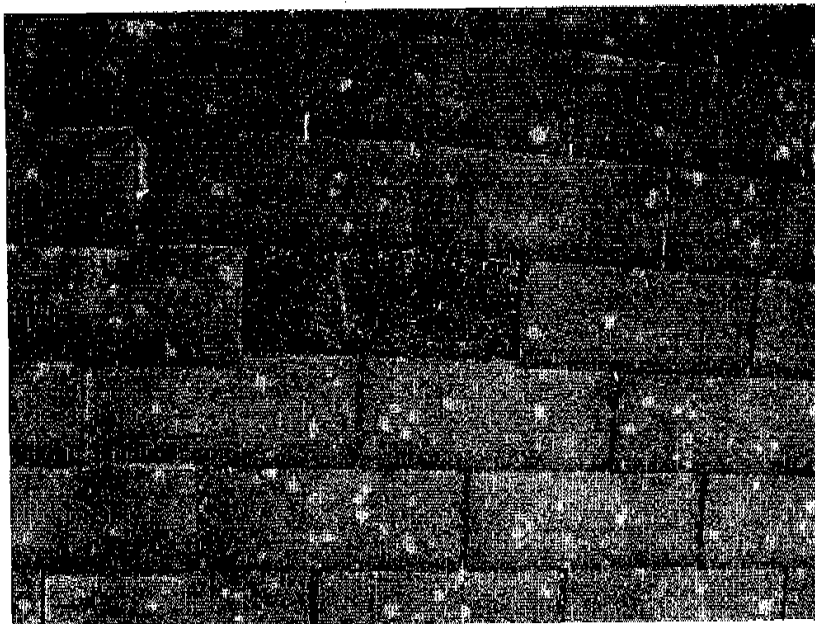
13 DSC00756

Wind damaged shingles.

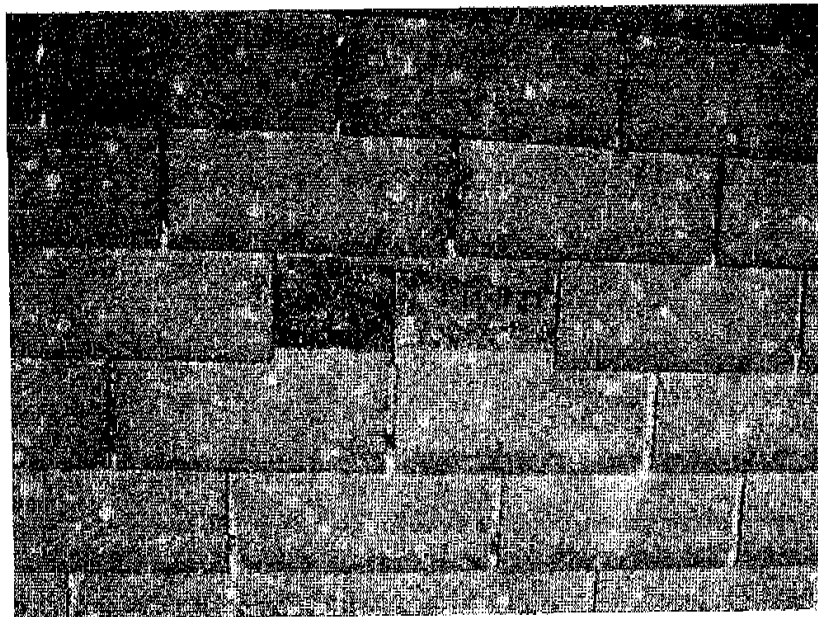
14 DSC00757

Wind damaged shingles.

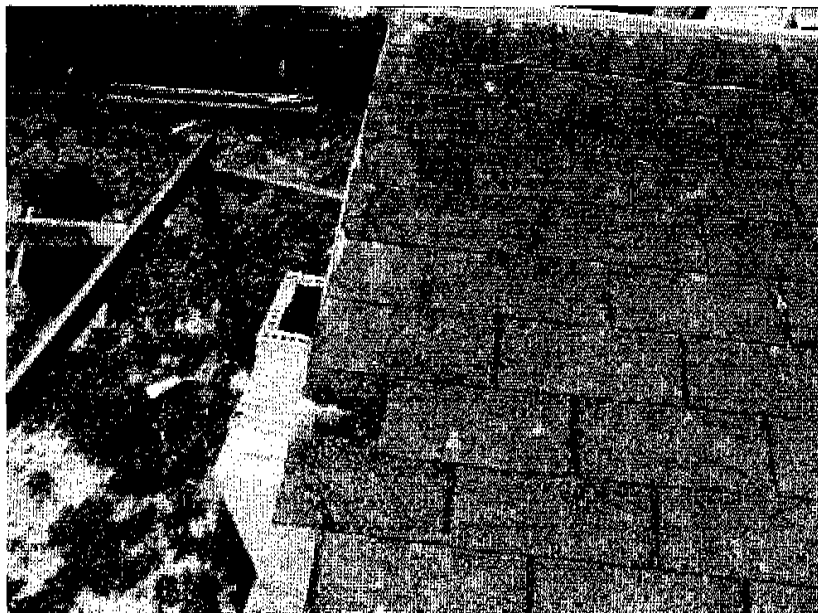
16 DSC00759

Wind and debris damaged shingles.

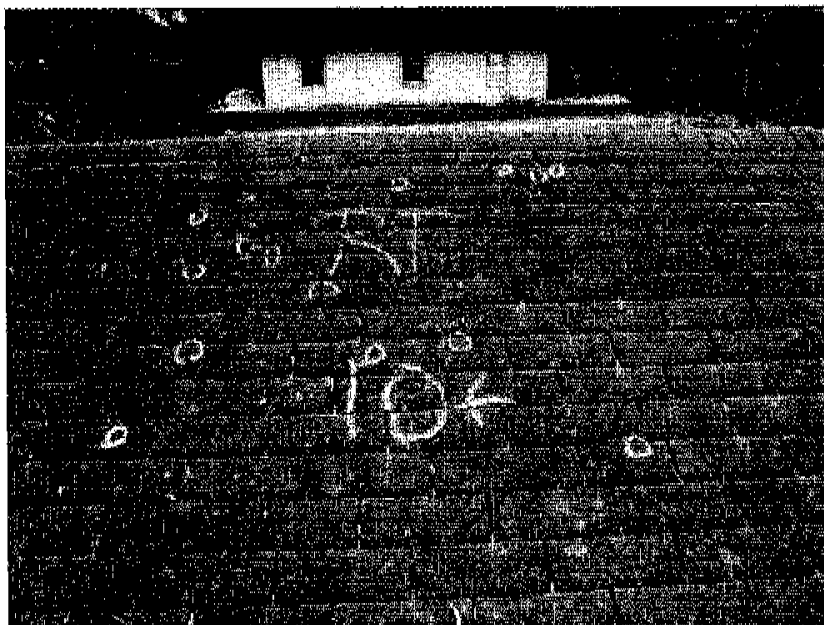
17 DSC00760

Right slope with 10+ impacts per square.

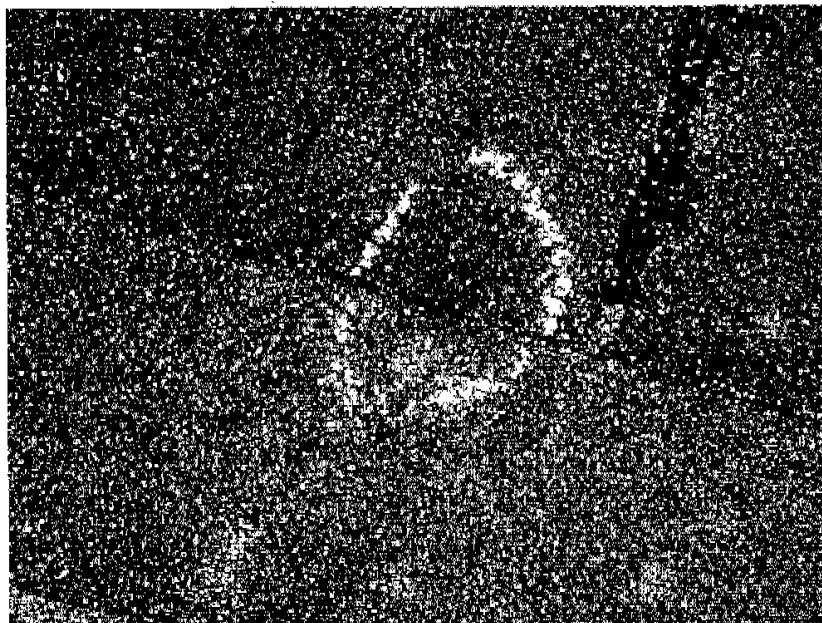
19 DSC00762

Hail to shingles.

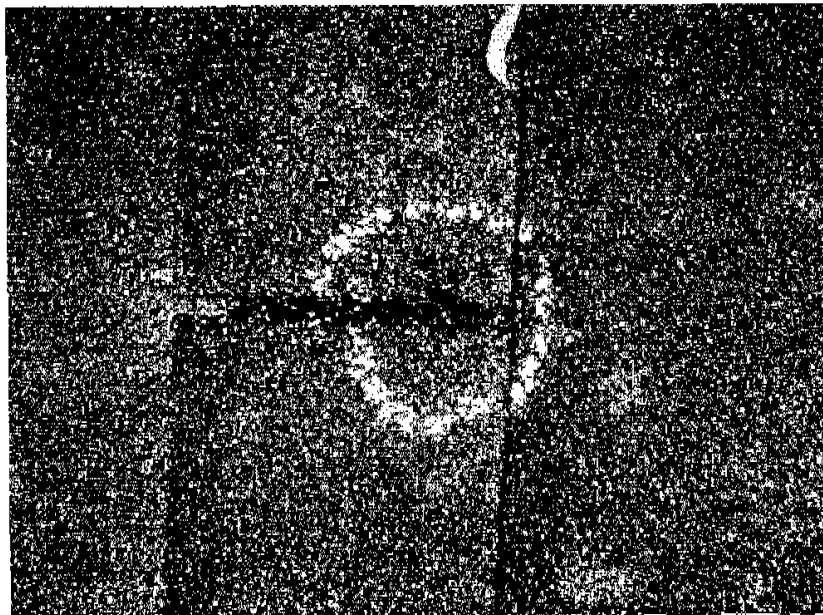
20 DSC00763

Hail to shingles.

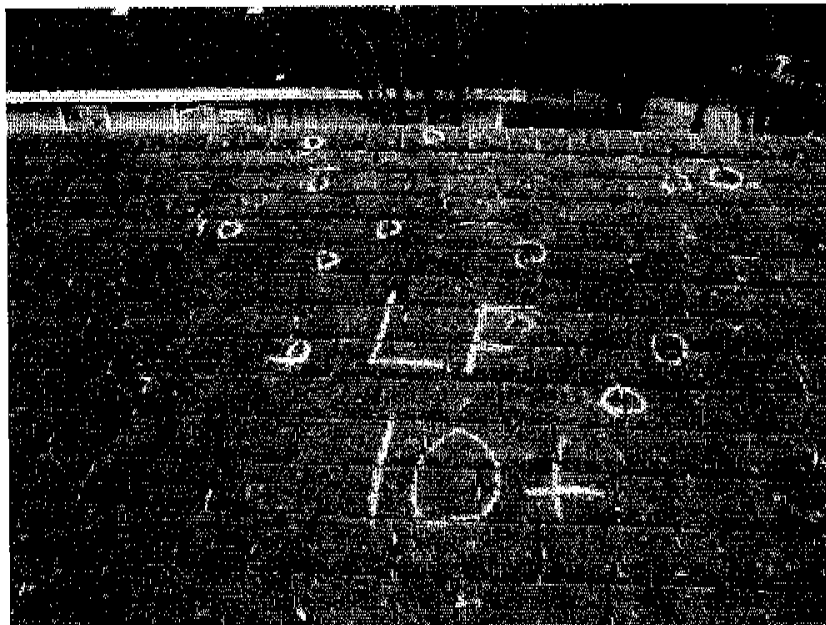
21 DSC00764

Left slope with 10+ impacts per square.

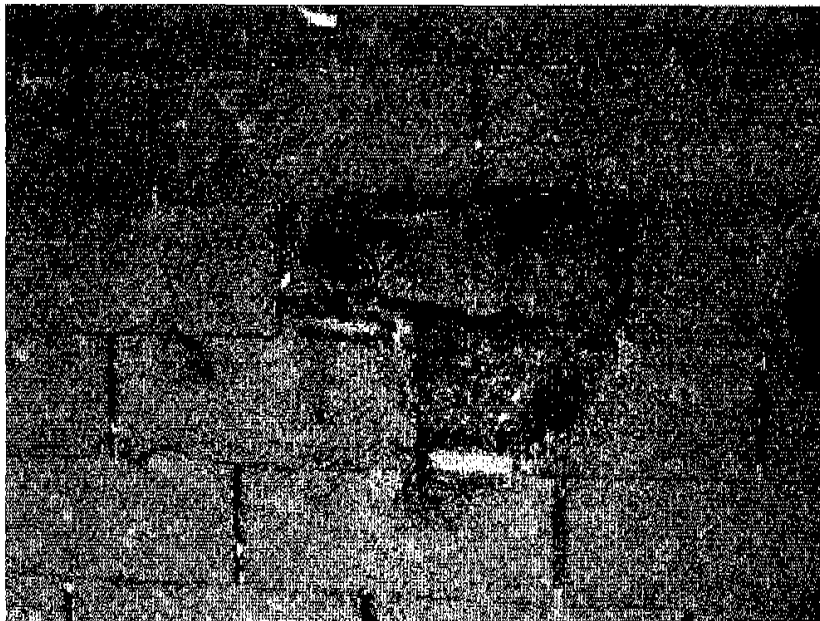
27 DSC00770

Wind damage to shingles.

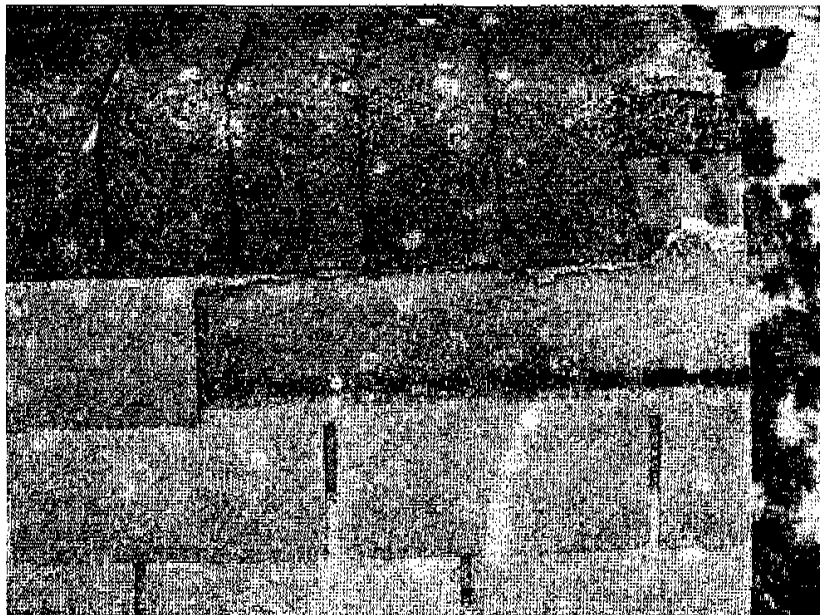
28 DSC00771

Wind damaged shingles.

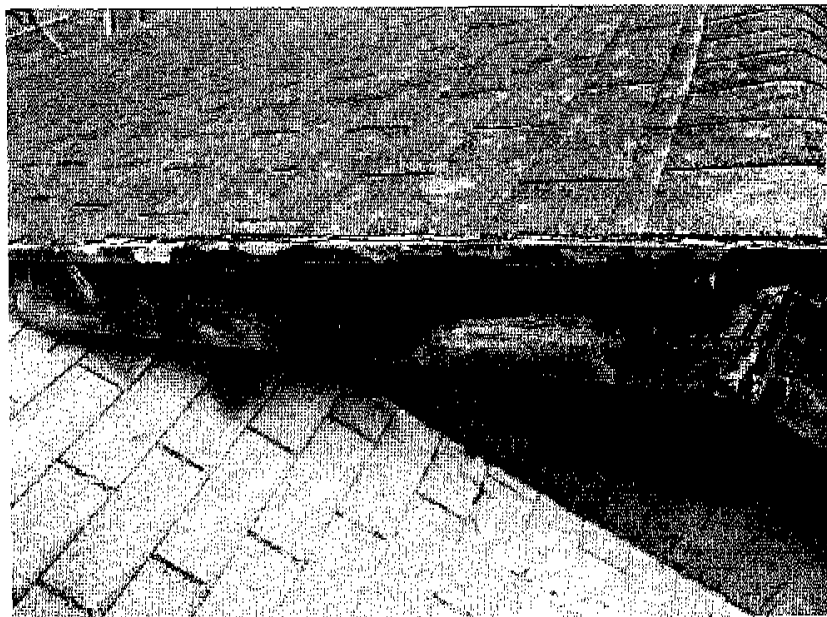
30 DSC00773

Water damaged fascia.

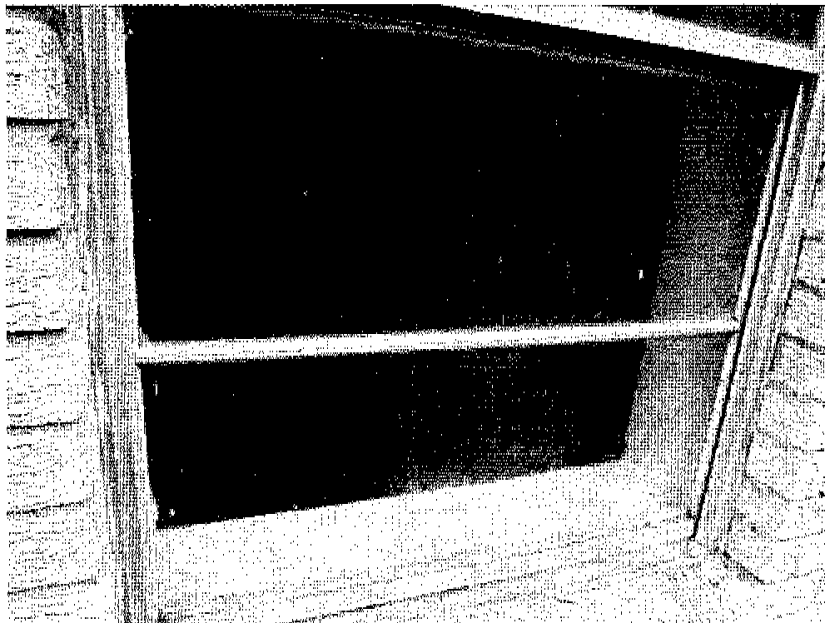
35 DSC00737

Window screen observed missing.

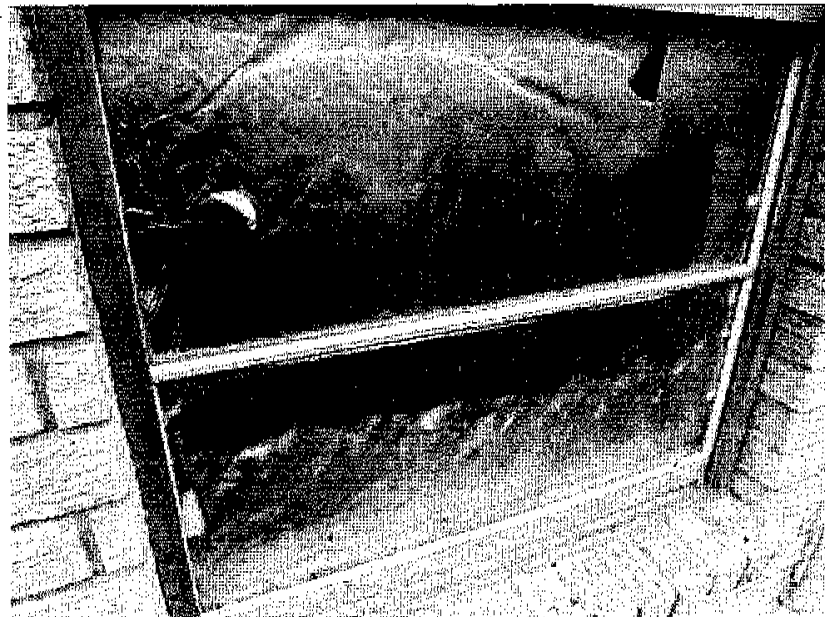
36 DSC00738

Window screen observed missing.

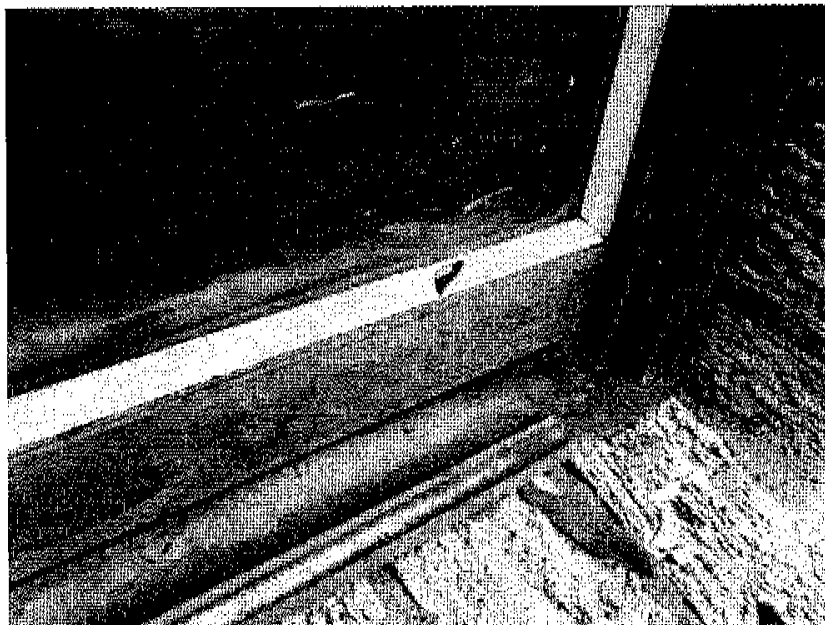
37 DSC00739

Hail damage to vinyl bead.

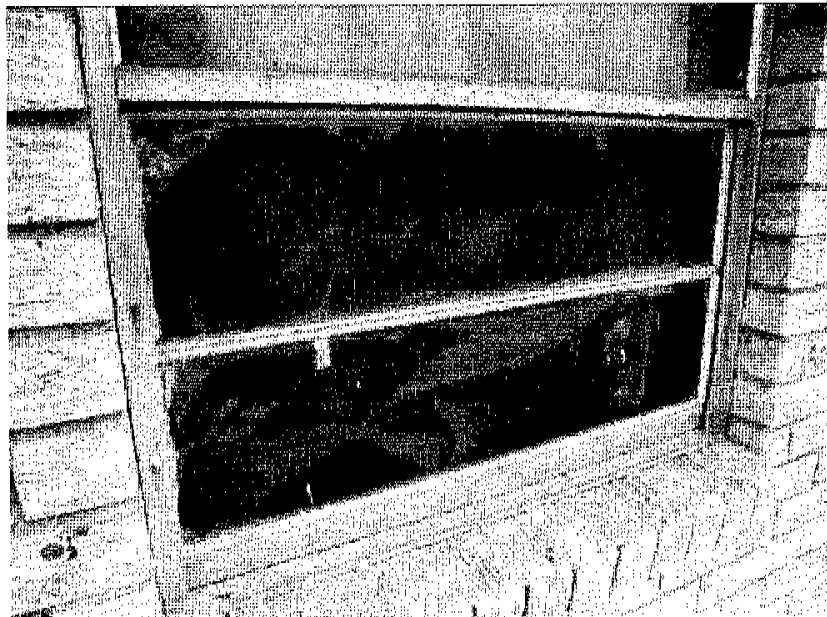
38 DSC00744

Window screen observed missing.

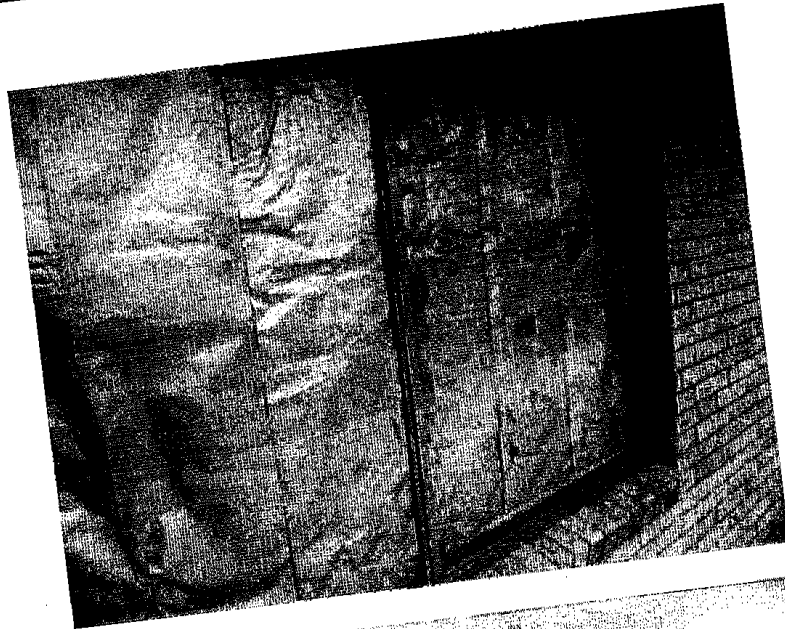
39 DSC00745
Date Taken: 1/29/2014
Taken By: Robert Molina
Window screen observed missing.
